DOURA POWER STATION  
UNITS 5 AND 6  
BAGHDAD, IRAQ

SUSTAINMENT ASSESSMENT

**SIGIR PA-07-103**  
**JULY 18, 2007**

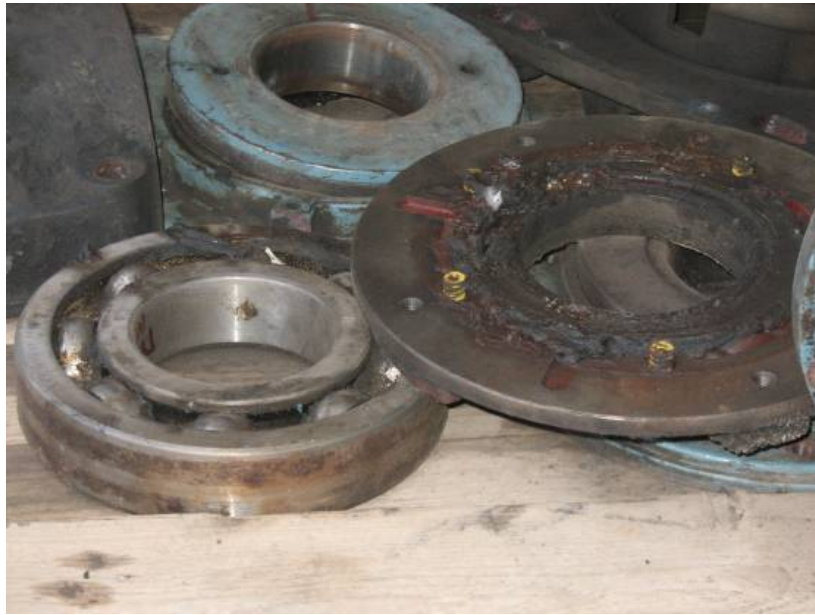
In addition, ineffective general maintenance of the exciter resulted in an oil and dust accumulation in the rotor end windings and rectifier wheel areas. The film of oil, dust, and mud created short circuit paths between the end winding connectors of the exciter. When combined with other operational problems, a short circuit (flashover) occurred and the exciter was rendered inoperable when the rotor windings were damaged. SIGIR observed a large bearing that failed and damaged the shaft on a piece of component equipment because of inadequate lubrication. One of the resident Electricity Sector managers agreed that lubrication is a key component of any effective preventative maintenance program. In this case, the bearing ran nearly dry and generated so much heat that it had to be cut for mechanics to remove the bearing from the rotating shaft (Site Photos 3 and 4).

**Site Photo 3. Inadequate lubrication caused bearings to fail. (10 June 2007)**

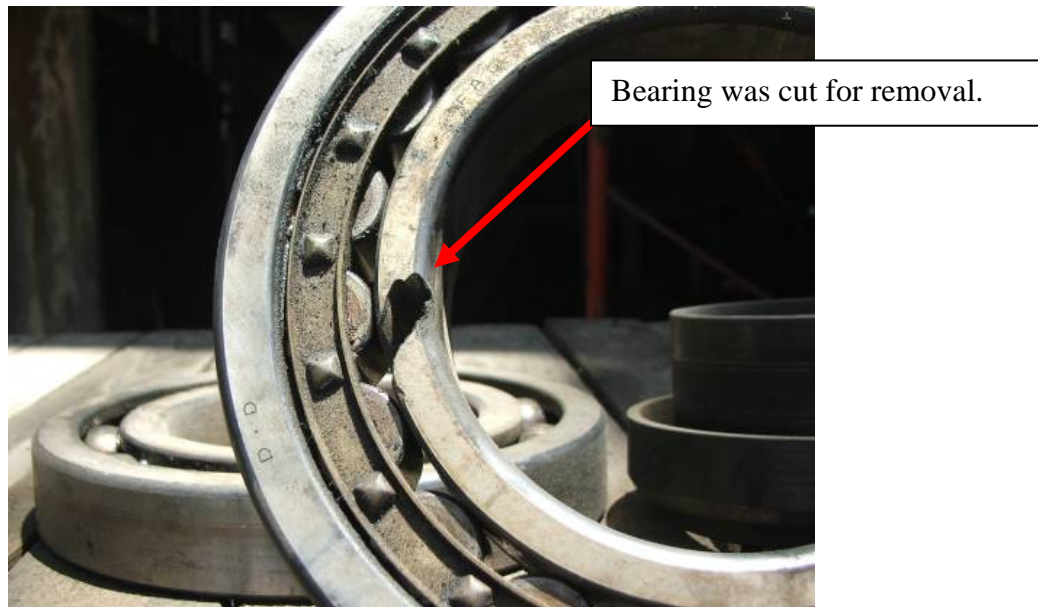
**Site Photo 4. Mechanics had to cut bearing before removal. (10 June 2007)**

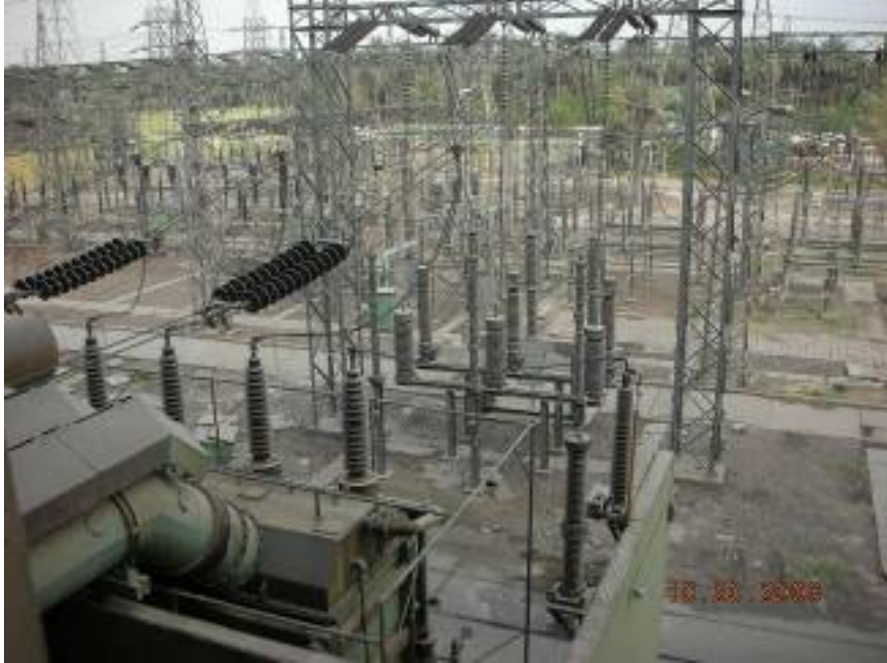
**Switchyard.** While operational at the time of our site visit, the switchyard should be overhauled. GRD Electricity Sector managers explained that, in the past, several insulators have been damaged from bullets and shrapnel and that most of the insulators need to be cleaned. The breaker control and protection circuits need to be tested (Site Photo 7). Resident GRD Electricity Sector managers, while working on the Unit 5 and 6 section of the switchyard, observed that several protections and controls have been bypassed and some high voltage breakers would not work remotely or were leaking SF6 insulating gas. Additionally, GRD Electricity Sector managers were not aware of any switchyard control or standard operating procedures (SOP) utilized by the MOE. Nonetheless, the MOE has total control of the switchyard and only allows contractor personnel to work on the Unit 5 and Unit 6 section(s) of the switchyard. Based on discussions with the resident GRD Electricity Sector manager, the switchyard lineup should be changed to ensure that power is distributed evenly from Units 3 through 6 to each outgoing line to avoid overloading any particular line section in the switchyard. At the time of our site visit, the resident GRD Electricity Sector manager stated that such a recommendation would be made in a timely manner before restarting Units 5 and 6.

**Site Photo 7. Unit 5 transformer and 132 kV switchyard is in questionable condition.**  
(Photo courtesy of Electricity Sector)
